Falk™ WRAPflex Couplings – Failure Analysis

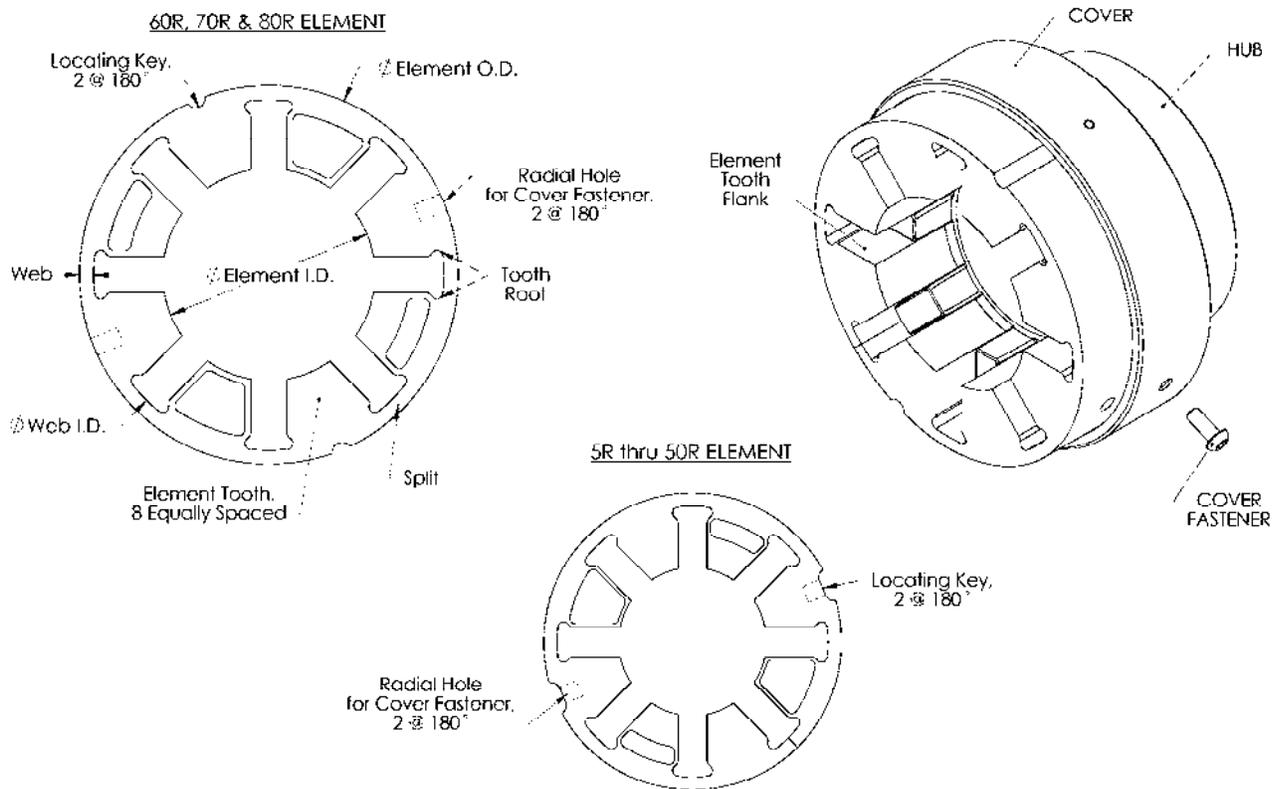
Figure 1 – WRAPflex Coupling & Element Features

The Falk WRAPflex coupling transmits torque primarily through “shearing” action of the flexible elastomeric element between the teeth of the driving and driven hubs. To a lesser extent, there is a “compression” component of loading on the element that will increase with higher torque loads (higher angular deflection) or higher angular misalignment. There is also a “radial” and axial component of load on the element because of the “V”-shaped element tooth. The flexible element, as shown in *Figure 1*, is the most highly stressed component of the WRAPflex coupling.

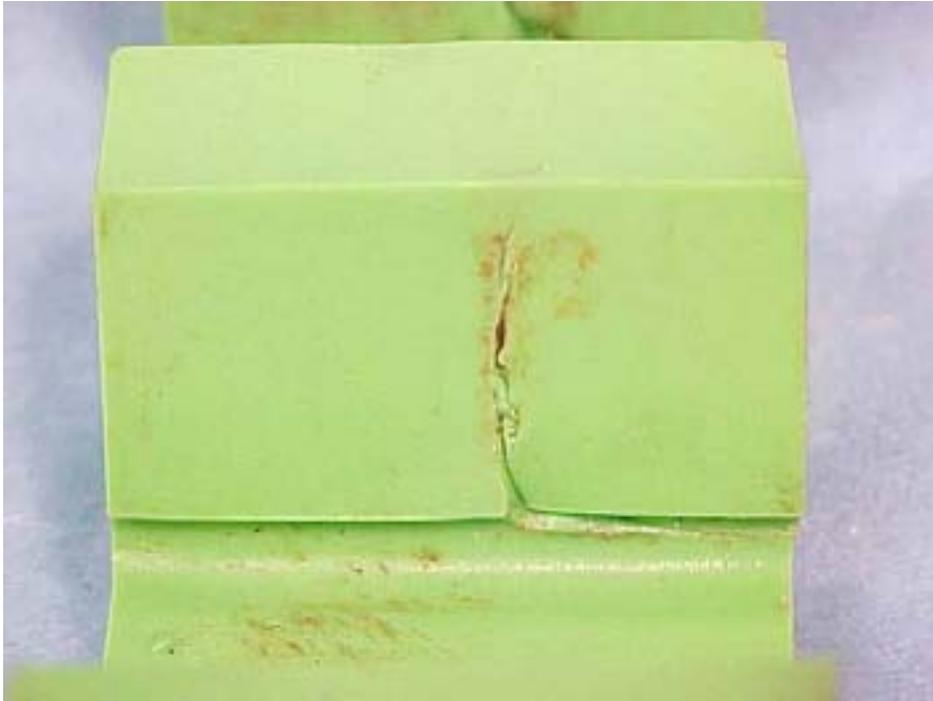
During a torque overload, angular deflection of the hubs is high. It can be as high as 10 times the normal deflection at rated torque. At such high angular deflections, the hub teeth act almost like shears. The forward, outer edge of the hub teeth begins to embed and tear/shear through the element material at the element tooth root, as shown in *Figure 2*. If torque continues to increase, the hub teeth will shear completely through the element and actually tear out portions of element teeth, as shown in *Figure 3*. If the equipment continues to run after an element failure, there is an increased possibility of cover failure.

Figure 2 – Tear in Element Tooth from Hub Tooth embedding under Torque Overload

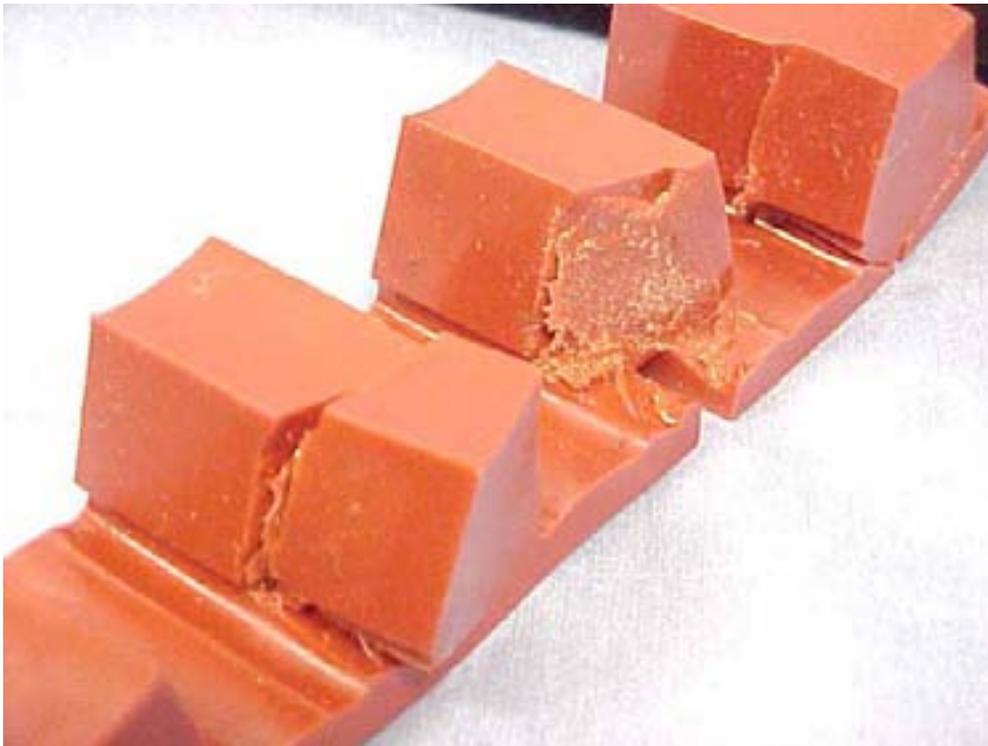
Figure 3 - Shearing of Element Teeth under Torque Overload

If properly selected, an ultimate strength failure should be rare. However, environmental factors can play a role and must be considered when analyzing a failure. Obviously, the best time to consider operating environment is prior to coupling selection. Certain chemicals or

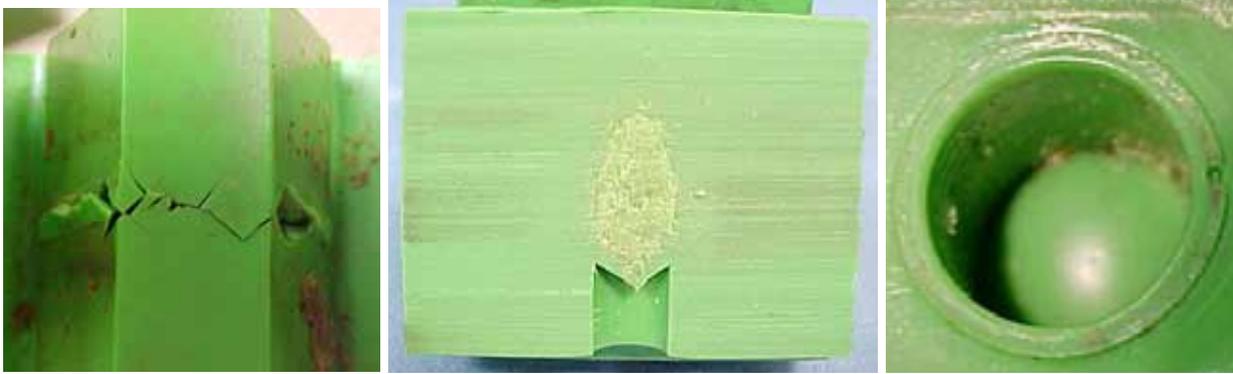
Under cyclical loading, the WRAPflex element dampens and absorbs a portion of the vibratory torque energy. The energy that the element absorbs is transformed as heat inside the element. If the amplitude or frequency of vibratory torque is so great that the element is not capable of dissipating the energy, internal temperatures within the element may become high enough to physically alter or break down the element material from the inside out. If this occurs, the element material will lose strength rather rapidly and will likely fail. A failure of this nature may appear outwardly similar in appearance to a torque overload or fatigue failure *Figure 4a*. The difference between the two types of failure can be discerned by either taking a cut through the center of a single element tooth, as shown in *Figure 4b* or by examining the element cover screw hole bottom for a “bulged” appearance (*Figure 4c*). *Figure 4b* reveals how heat build-up due to vibratory torque breaks down and transforms (melts) the element material from the inside out. An element that has failed due to pure torque overload or low frequency/load fatigue will not show any physical break down of the element material. As with torque overload, exposure to certain chemicals or extreme hot or cold may also be a factor in a fatigue type failure.

a) Element Tooth Failure b) Cut Thru Element Cover Hole c) Element Cover Hole Bulge

Figure 4 - Heat-Effectuated Element Tooth due to Vibratory Loading

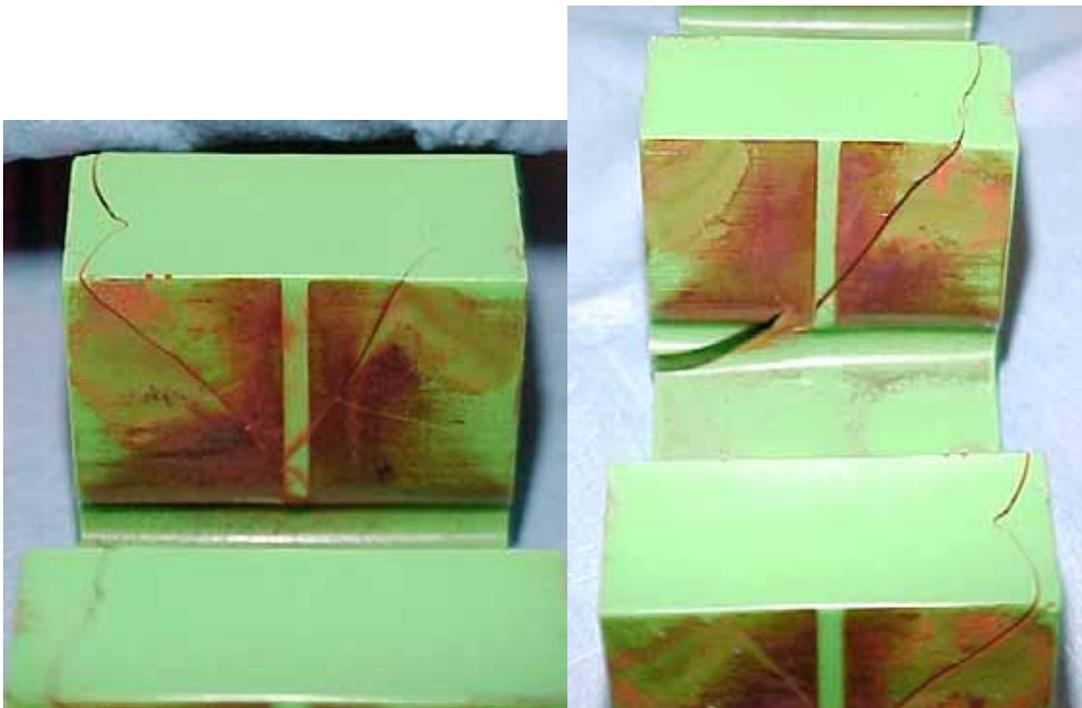
Vibratory torque can also give rise to a relatively slow fatigue failure, if heat build-up within the element is not excessive. In this case, cyclical loading leads to a slow progression of cracks in the element, without physically breaking down the element material. Cracks begin to form on the tooth flank and at the tooth root. Often, two cracks will converge near the center and root of one tooth flank and angle outward to the element I.D., as shown in the left-hand photo of *Figure 5*. Over time, flank cracks will continue across the I.D. and actually join the cracks on the opposite flank. Cracks at the root or web of the element typically start on one side and progress towards the center of the element. Surprisingly, the WRAPflex element will continue to carry full torque even after it has become severely cracked. For this reason, a replacement element is recommended only if a piece of element tooth has broken off or is close to breaking off, or the element is close to separating at the web.

Figure 5 - Flank & Web Cracks on Element Teeth due to Vibratory Loading (Fatigue)

A rusty orange residue is visible on the element tooth flanks, as shown in *Figure 5*, and on the hub teeth. This residue is due to fretting corrosion. Fretting is a result of friction when the hub teeth slide against the element teeth during vibratory loading. It is not uncommon for this type of coupling and should not be construed, in and of itself, as an indicator of failure.

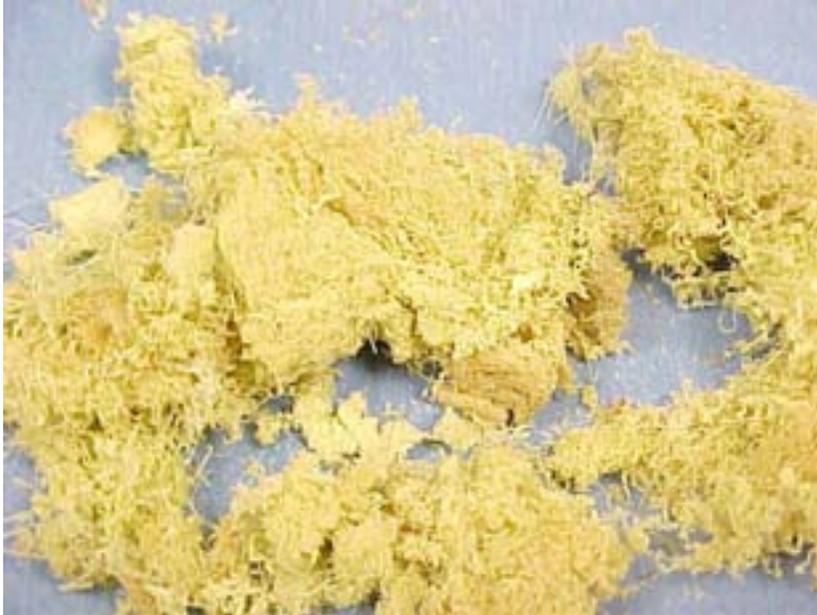
When the WRAPflex coupling runs under high angular misalignment, one hub tends to grip the element while the other hub works back and forth against the element. This back and forth working motion and the related friction is the mechanism that causes wear. Wear debris, as shown in *Figure 6*, will accumulate over time and is a good indicator of high angular misalignment.

Figure 6 - Element Wear Debris due to Excessive Angular Misalignment

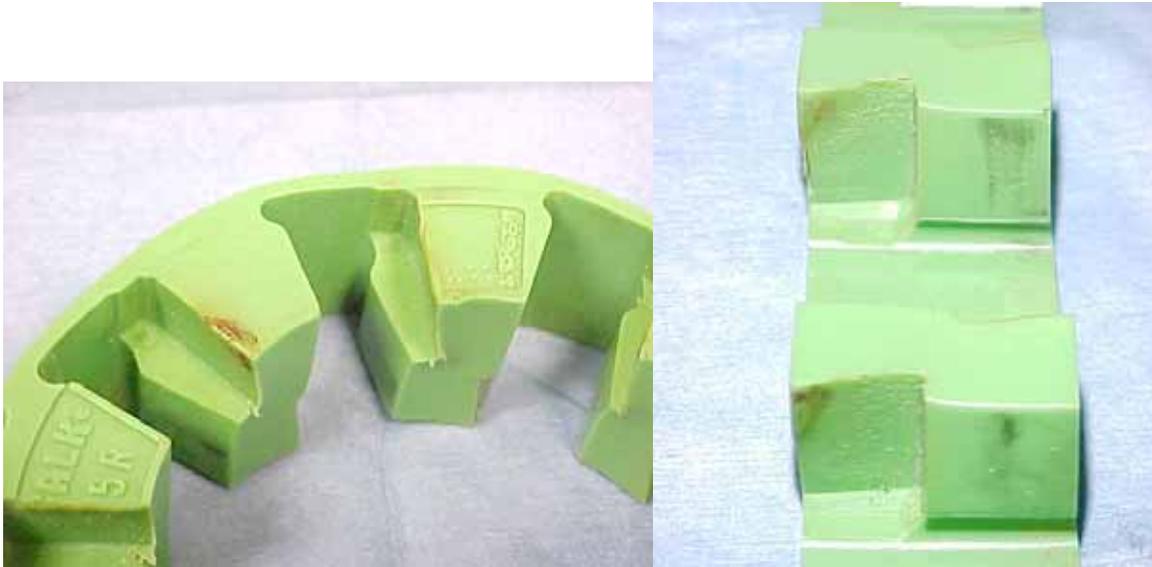
One side of the element is generally unaffected (typically compression set or distortion of urethane rather than abrasive wearing of urethane contact surface), but the other side that sees the working motion from one hub begins to wear away, as shown in *Figure 7*. Eventually, enough of the element tooth will have worn away so that the remaining portion of

Figure 7 - Partial Element Tooth Wear due to Excessive Angular Misalignment

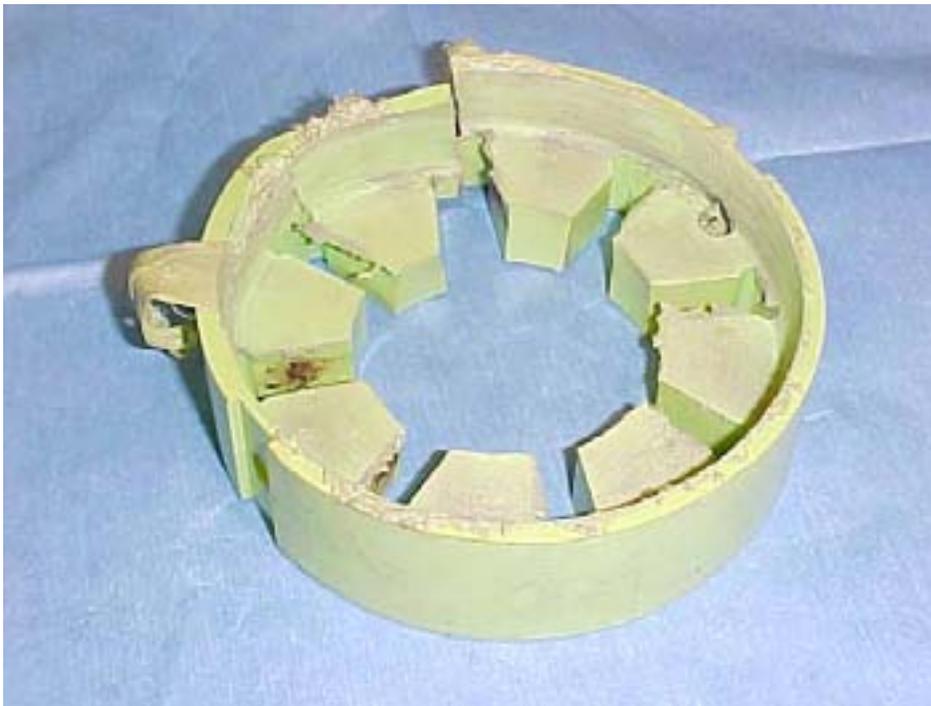
tooth can no longer carry the load. At this point, the remaining portion shears away and the coupling fails. If the problem is not discovered until after the element has failed, the hubs spin free. While free spinning, the cover may be damaged and the element will actually begin to melt due to the high speed friction forces, as shown in *Figure 8*.

Figure 8 – Complete Wear Failure & Melting of Element after Free Spinning, due to High Angular Misalignment

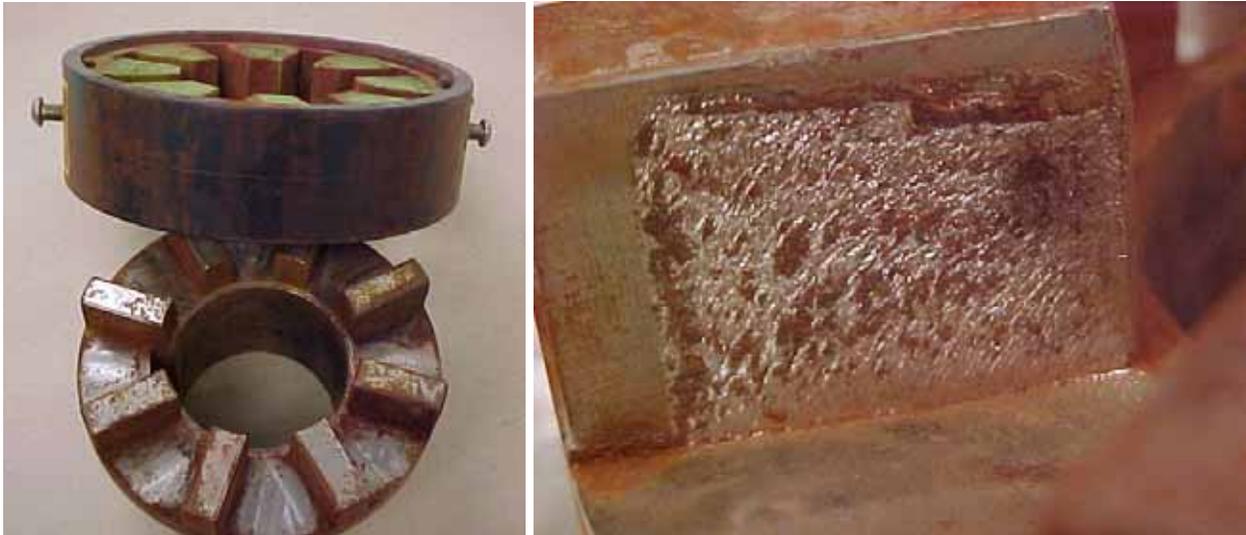
Under severe vibratory loads (i.e. pump cavitation, system resonance frequency or non-flywheel engine drive systems) or lightly loaded applications (i.e. very large service factors due to bore capacity, etc.), the urethane element may wear the hub steel teeth. This aggressiveness may create a fretting corrosion condition (a red powdery abrasive dust) that may wear the hub teeth as shown in *Figure 9*.

Figure 9 - Abrasive Wear due to Element Material Fretting Corrosion

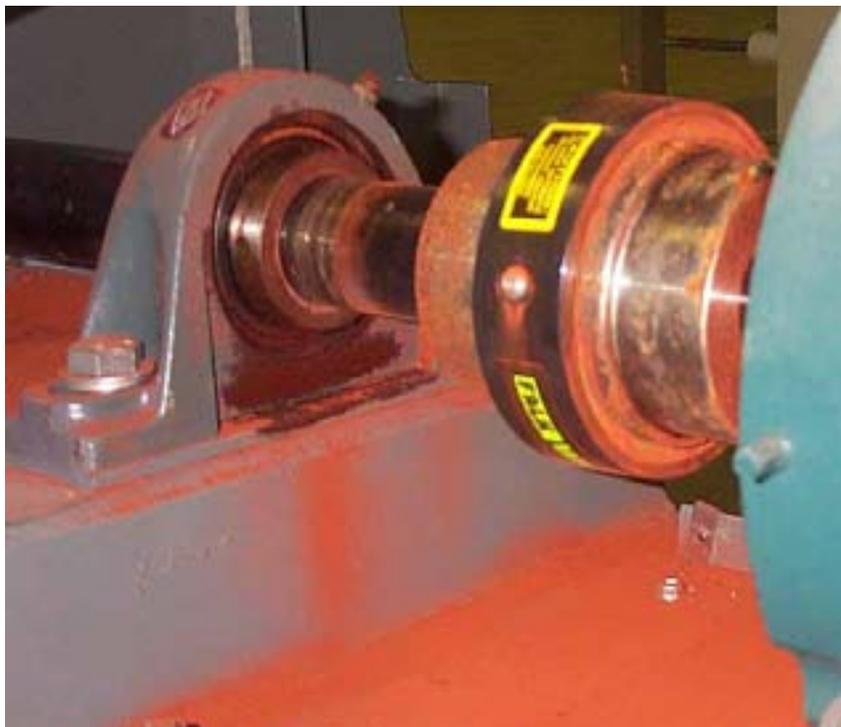
This condition is usually observed by excessive red dust covering the coupling and surrounding surfaces as shown in *Figure 10*.

Figure 10 - Red Fretting Corrosion Dust when element Operating Under Severe Vibratory Loads
