## Fruitland 250,370 and 500 Pump Rebuild Procedure

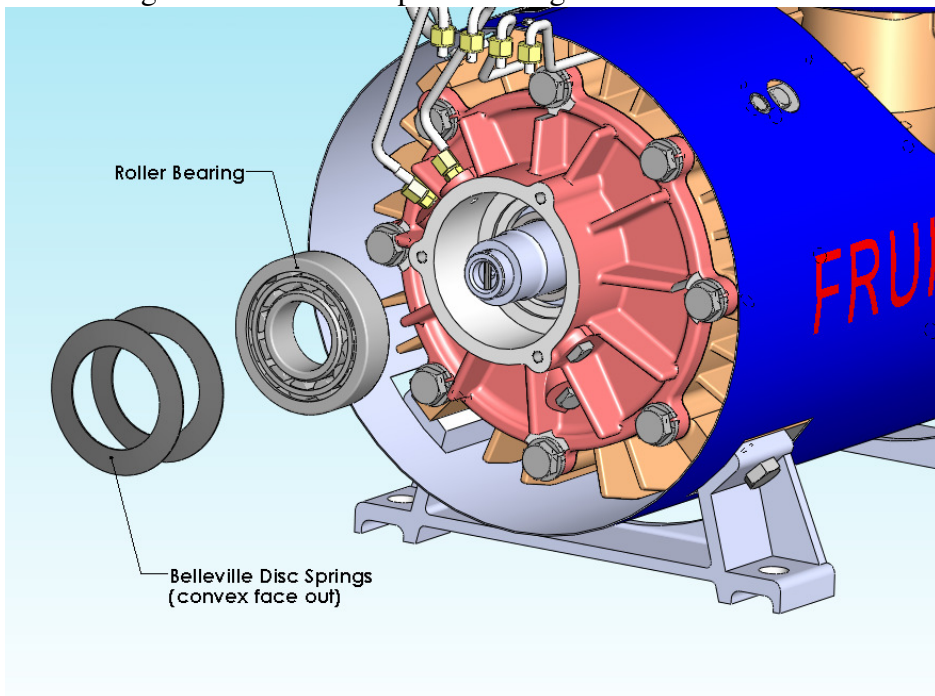
- A main roller bearing and 2 disc springs are located in the main housing end cap. Make a note of the direction of the 2 disc springs. They are conical in shape and go back in the same direction (Pointing out). If unsure, call the toll free number for clarification. Improperly installed disc springs may cause overheating and rotor and end plates damage.

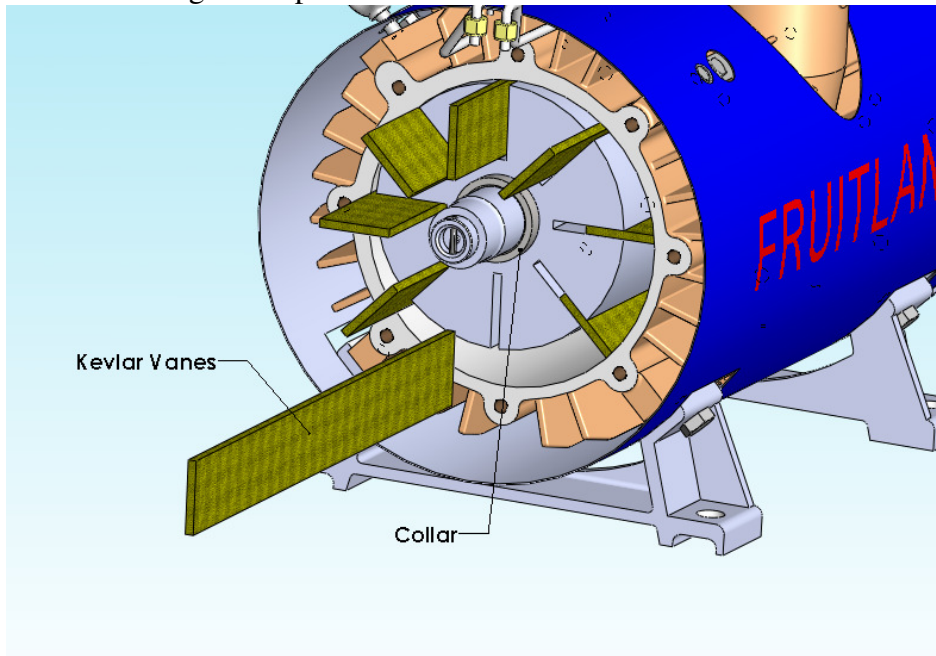
- When the housing end cap is removed, the rotor will drop approximately 3/16" due to the weight of the rotor not being supported. When re-installing the end cap, the rotor will have to be lifted that amount to relocate end cap recess back into housing bore.
- After removing end cap. Remove vanes and check the condition of vanes, vane slots, and housing bore.

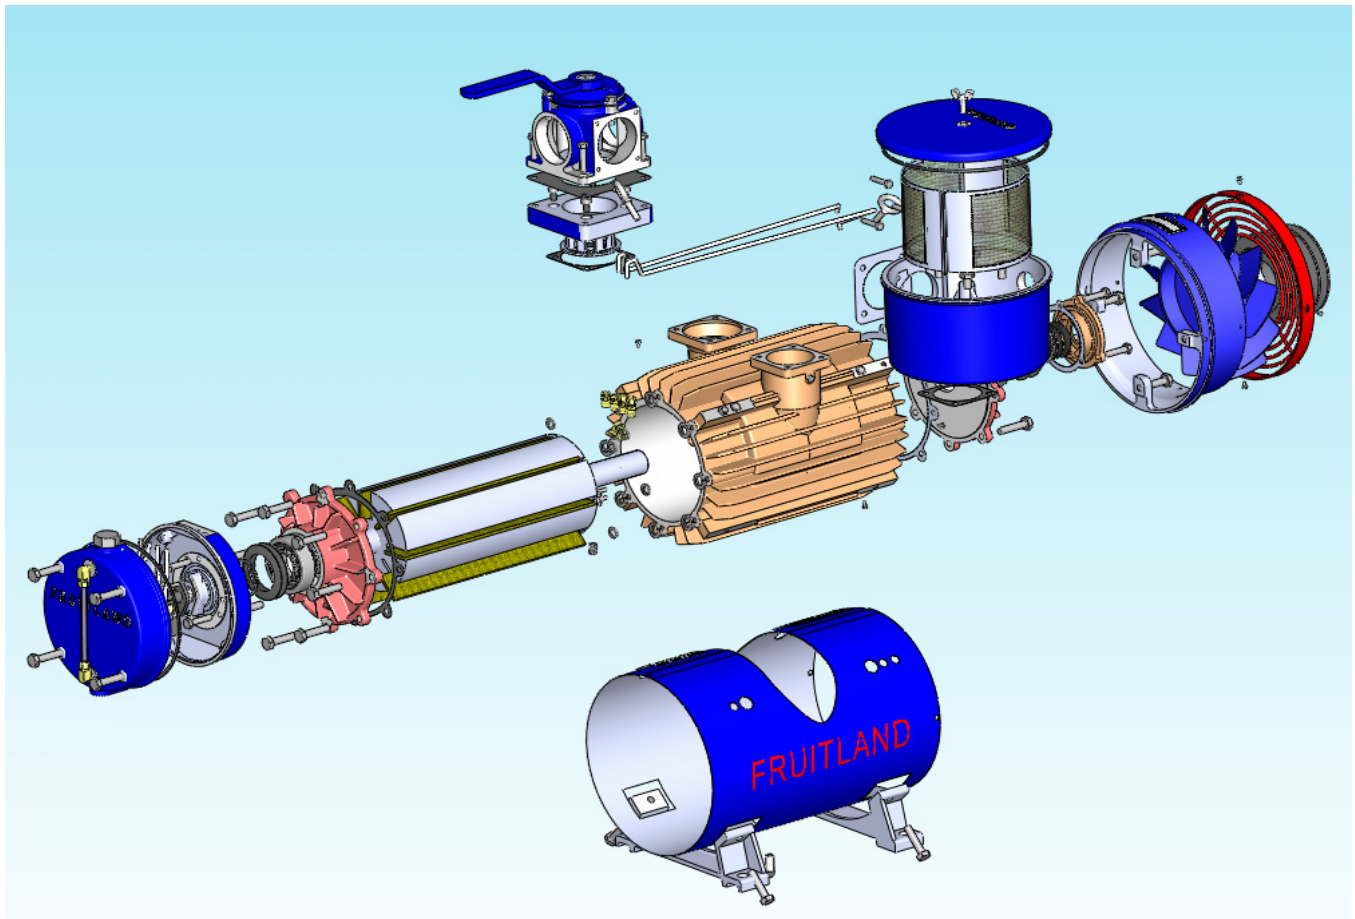
- The rotor should be removed from the pump, if the vanes are difficult to remove, if the bearing or the rotor is damaged, or if there is contamination in the pump. This also allows inspection of the bearing on the drive end. If a bearing has to be replaced, the inner bearing race will have to be removed from the rotor shaft with a puller, as it is a press fit on the rotor shaft. The collar between the bearing race and rotor end face can be re-used if not damaged.
- Check condition of the housing bore. If pump was disassembled because of a broken or damaged vane, check for housing cracks. Housing must be replaced if a crack is detected.
- If housing bore is in good shape, assembly procedure can start. New well oiled vanes should slide in and out of the rotor slots easily.
- Re- install parts in reverse order from disassemble
